# Filamentous Algae In Stormwater Pond

USILST-LOC109.001

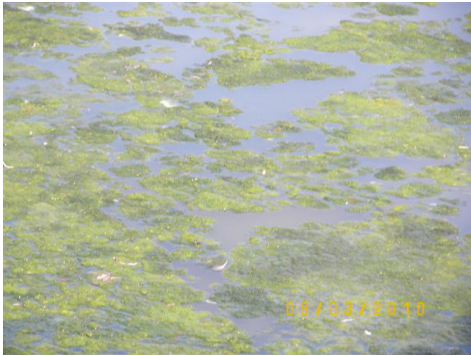
**Photos:** The first photo shows filamentous algae coverage in summer 2008; the middle photo is a SB10000 in action; photo on right is from summer 2010 showing significant filamentous algae reductions.

Because of its shallowness and having high-nutrient stormwater runoff for source water, this pond had a history of blue-green algae (cyanobacteria) blooms that caused odors, as well as excessive filamentous algae growth that would cover much of the pond surface. The pond would often be stagnant, lacking sufficient circulation.
