## ResidualHQ© Deployment & Initial Operation Report

This paper analyzes the field deployment of the first ResidualHQ© Automated Disinfectant Control Workstation (RHQ).

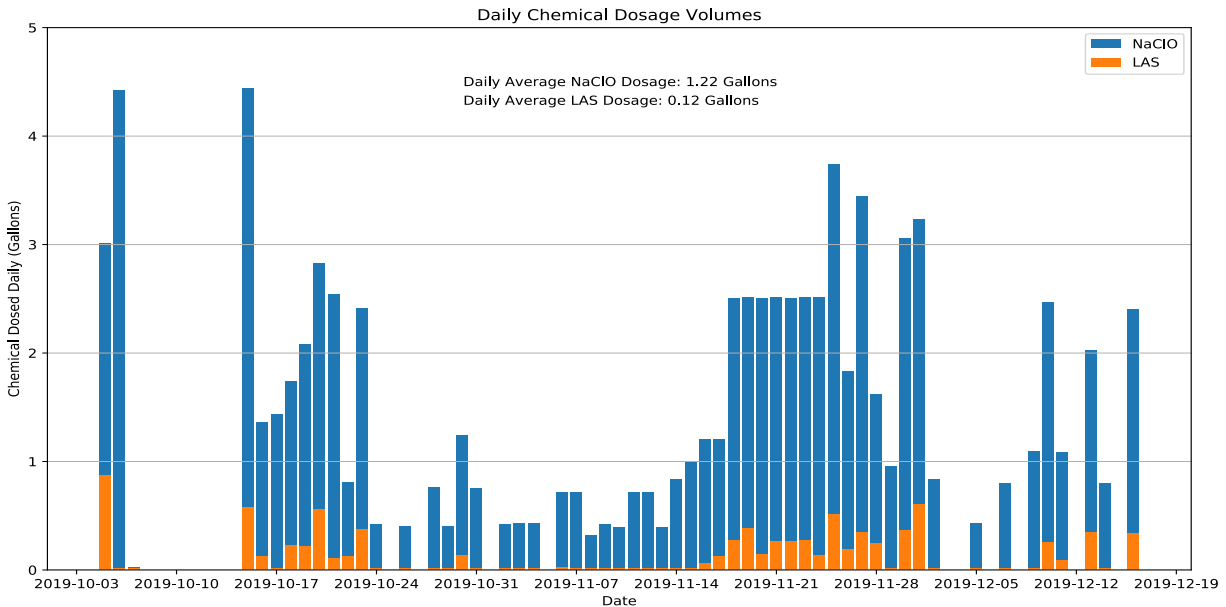
## ResidualHQ® Operation Analysis Figure 1

Figure 1: Graph showing the daily chemical usage of the RHQ workstation. Blue indicates 12.5% Sodium Hypochlorite was dosed and orange indicates Liquid Ammonia Sulfate was dosed.

**Figure 1-** This graph shows the average daily chemical dosing performed by the RHQ system.

Initial startup of the RHQ on October 5<sup>th</sup>, 2019 required the greatest amount of chemical dosage. Once the total chlorine residual was within the desired range, much smaller doses were needed to maintain the target residual. The RHQ dosed consistently under one gallon per day of sodium hypochlorite from October 24<sup>th</sup>, 2019 through November 13<sup>th</sup>, 2019.

Once the customer observed disinfectant residuals trending as intended, they reduced chemical dosage upstream by 30% starting November 11, 2019. This caused an increased need for chemical dosing at the RHQ location; however, the Dose Volume Limit was not adjusted upward to accommodate for the new demand from November 18-24, 2019. Once the Dose Volume Limit was set to allow higher daily doses when needed, the disinfectant residual recovered to within the target range.

Starting on December 2<sup>nd</sup>, 2019, the chemical demand again fell, this time due to less chemical needed to maintain residual within target parameters for the given water condition at the time.

Another important consideration depicted in Figure 1 shows the comparison of gallons dosed of LAS to NaClO was approximately 10% over time rather than 20% as would be the case for a 5:1 chemical feed ratio. This is because the RHQ starts dosing NaClO first to combine with any free ammonia. If an NaClO dose causes the subsequent total chlorine residual to fall below the initial pre-dose chlorine residual, the RHQ system will then dose LAS and NaClO (chloramine) until the Target Residual Threshold reaches the 2.0 mg/l set point.

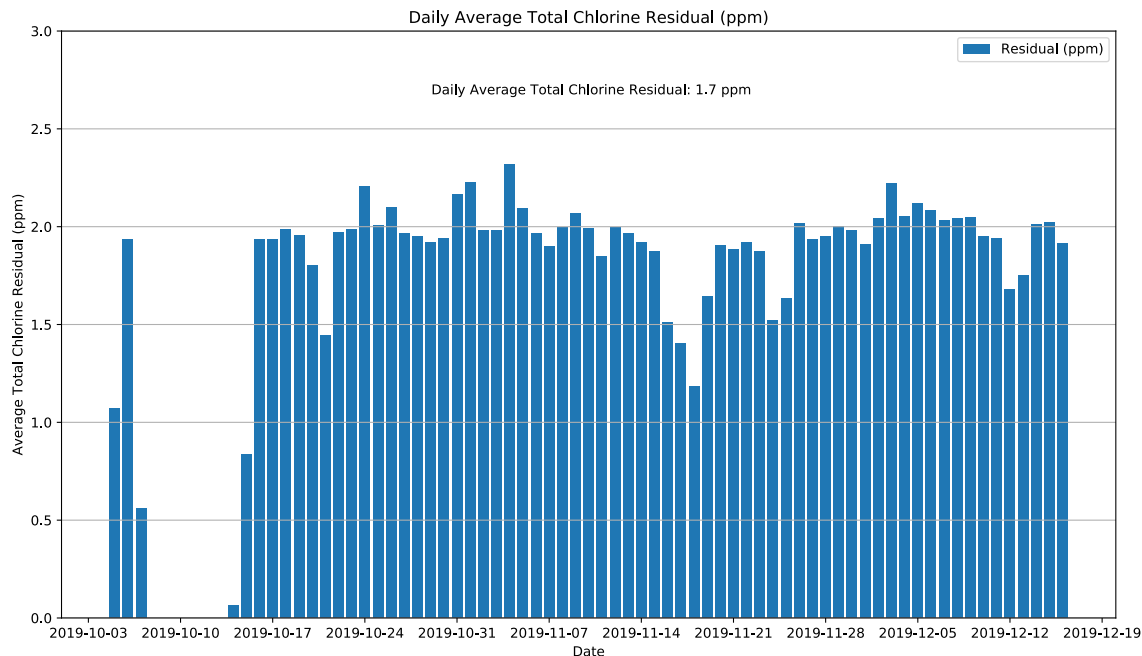
## ResidualHQ® Operation Analysis Figure 2

Figure 2: Graph showing the daily average Total Chlorine Residual measured by the RHQ workstation.

**Figure 2-** This graph depicts the daily average Total Chlorine Residual in the water tank. The initial startup procedures on October 5<sup>th</sup>, 2019 manually raised the residual to 2.0 mg/l; however, the RHQ needed to be turned off the following week while the customer worked through SCADA issues with their tank level sensor. Subsequently the RHQ began automated operation on October 14<sup>th</sup>, 2019 and by October 16<sup>th</sup>, 2019, the total chlorine residual was within the target range.

**Figure 2, Event 1-** On October 21, 2019, the water tower location lost power and the RHQ was off for approximately 10 hours. During this time the daily average residual went below 1.5 mg/l for the day. The RHQ was subsequently restarted by the operator.

From October 22, 2019 to November 14, 2019, the residual levels inside the water tower were consistently within the 1.8 mg/l to 2.2 mg/l total chlorine residual range.

**Figure 2, Event 2-** The RHQ began to record a drop in residual starting on November 14, 2019. This correlates with the operator reducing chemical dosage upstream. The RHQ system dosed chemical up to its pre-set daily volume limit of 2.5 gallons, which was lower than necessary value. The daily volume limit was adjusted on November 25<sup>th</sup> and by November 26<sup>th</sup>, the daily average total chlorine residual was within the acceptable range.

**Figure 2, Event 3-** On December 12, 2019, the RHQ recorded another drop in residual. This was due to an error encountered by the RHQ. The RHQ stopped dosing but continued to circulate water through the system to monitor total chlorine residual level. The NaClO was gassing off in the line from the bulk tank due to infrequent dosing. The valve was physically fine, so the system was reset through the HMI and the RHQ resumed normal operation. The issue has been resolved by changing dosing parameters, to use smaller doses more regularly.

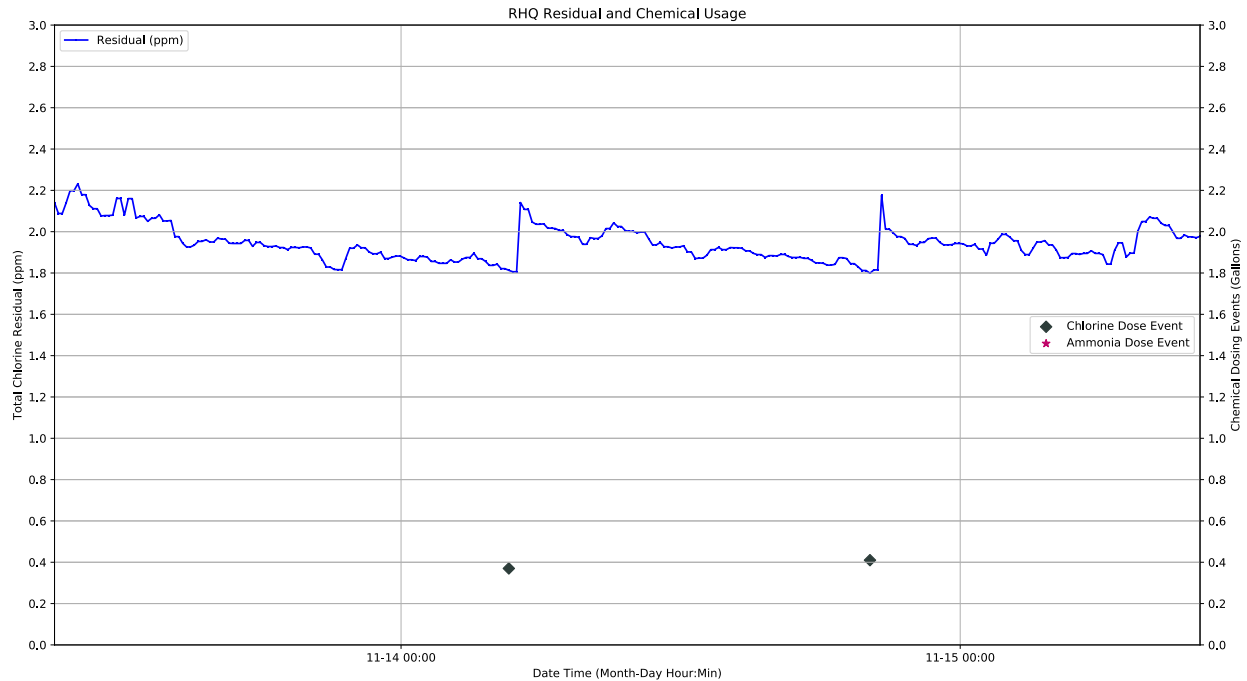
### ResidualHQ© Operation Analysis Figure 3

Figure 3: Two days of residual and dosing recorded by the RHQ.

**Figure 3-** This graph shows the residual trendline as recorded by the RHQ system. The system parameters were set to:

- Low Residual Threshold: 1.8 mg/l (triggers dosing)
- Target Residual Threshold: 2.0 mg/l (stops dosing)

In this particular graph, only chlorine was needed to boost the disinfectant residual.

After each dose event was completed, the RHQ waited for a set amount of time before determining if another dose is necessary (known as the Determination Wait Time). If total chlorine residual stays above the Target Residual Threshold longer than the Determination Wait Time, the RHQ transitions to “Monitoring Only” until the total chlorine residual hits the Low Residual Threshold which then triggers another dose event.

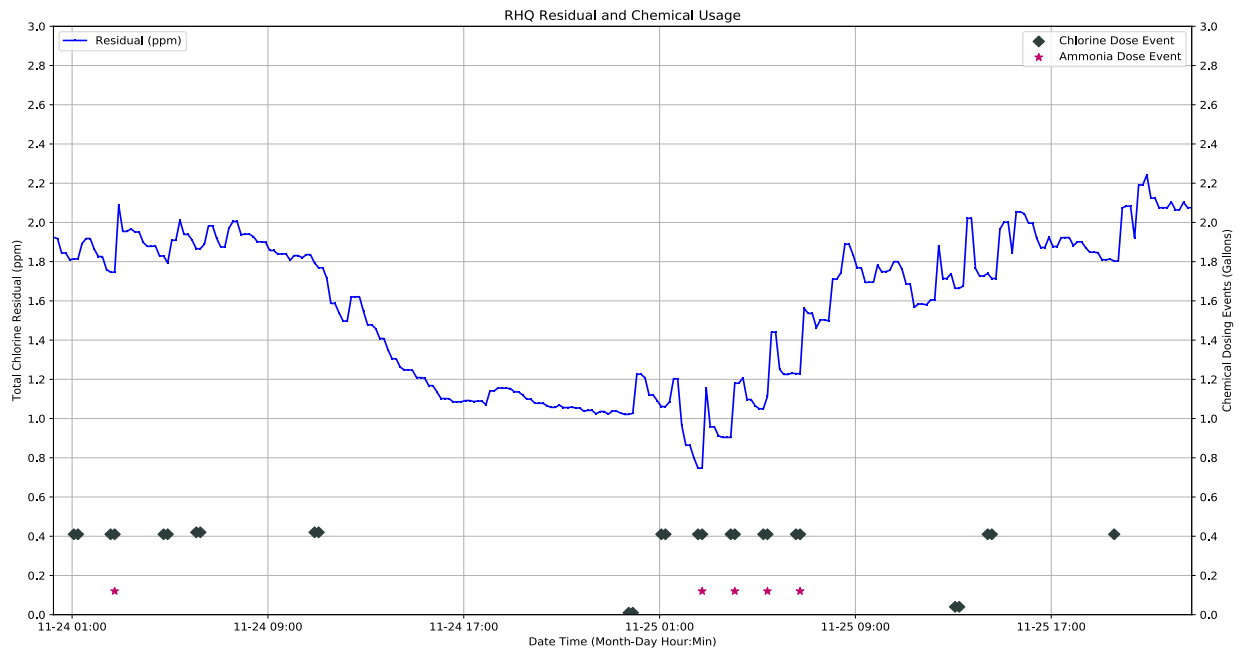
## ResidualHQ® Operation Analysis Figure 4

Figure 4: The residual dipped due to the daily chemical volume limit set too low. The limit was increased later in the day on 2019-11-25.

**Figure 4-** This graph details how the RHQ reacts to low residuals and how the RHQ reacts when the water no longer has free ammonia to bind with free chlorine.

It was determined the disinfectant residual trended downward because:

- The operator reduced chemical dosing up stream and
- The RHQ Dose Volume Limit was set too low.

Early in the morning of November 25<sup>th</sup>, the Dose Volume Limit was adjusted upward. When the RHQ started dosing NaClO, the total chlorine residual was observed to fall instead of rise. This indicated there was no longer free ammonia in the water to bind with the free chlorine.

The RHQ then switched over to create and dose chloramine.

This is achieved via the RHQ Pre-Mix Tank where LAS and NaClO are diluted with water, mixed, and dosed. Figure 4 shows how the incremental doses stairstep the total chlorine residual to the target value of 2.0 mg/l.

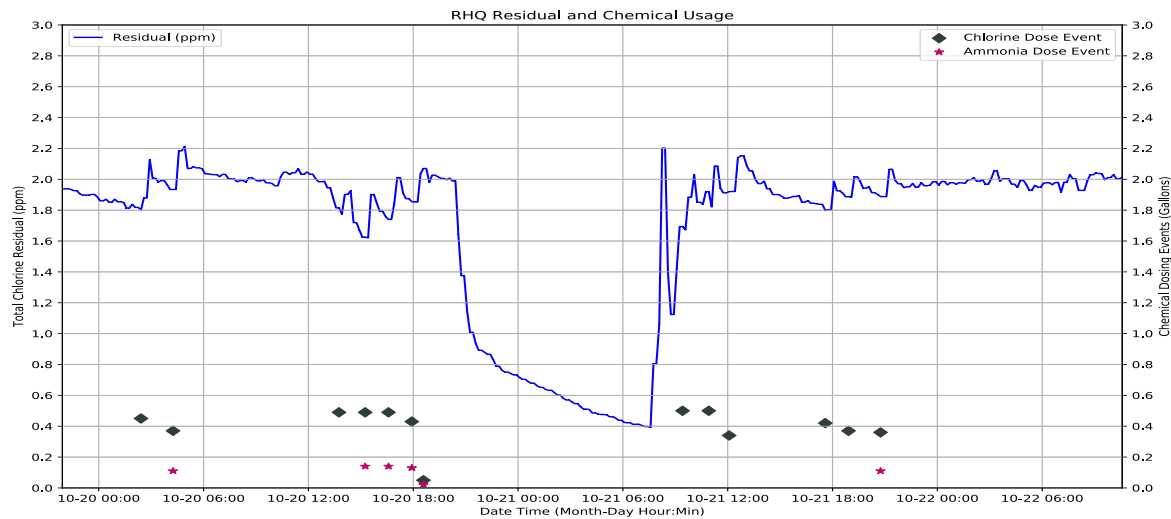
## ResidualHQ® Operation Analysis Figure 5

Figure 5: This graph depicts the residual level when power supply was lost to the RHQ due to a storm outage. All systems stop and the residual levels are incorrect as water is no longer flowing through the RHQ.

**Figure 5-** This graph depicts a power loss event at the RHQ site the night of October 20<sup>th</sup> due to a storm. Power was restored after a few minutes; however, the RHQ was purposefully set for manual restart (rather than automatic) after loss of power. The system was offline and not circulating for a short period of time in which a drop in total chlorine residual was observed. It is important to note the drop in total chlorine was not from water in the tank itself but from stagnant water in contact with the chlorine sensor in the flow cell.

At 8:00 am on October 21<sup>st</sup>, the RHQ was restarted and the residual can be seen to rise quickly and then fall back down. After the system restarts, the RHQ implements an “action timeout period” to allow the system to stabilize before taking any action to correct low residuals. After the action timeout, dosing resumed and the disinfectant residual recovered to above 2.0 mg/l.
