# Cyanobacteria Control In A Small Raw Water Pond

**Topics:** cyanobacteria, blue-green algae, aquatic weeds, raw water, cost savings

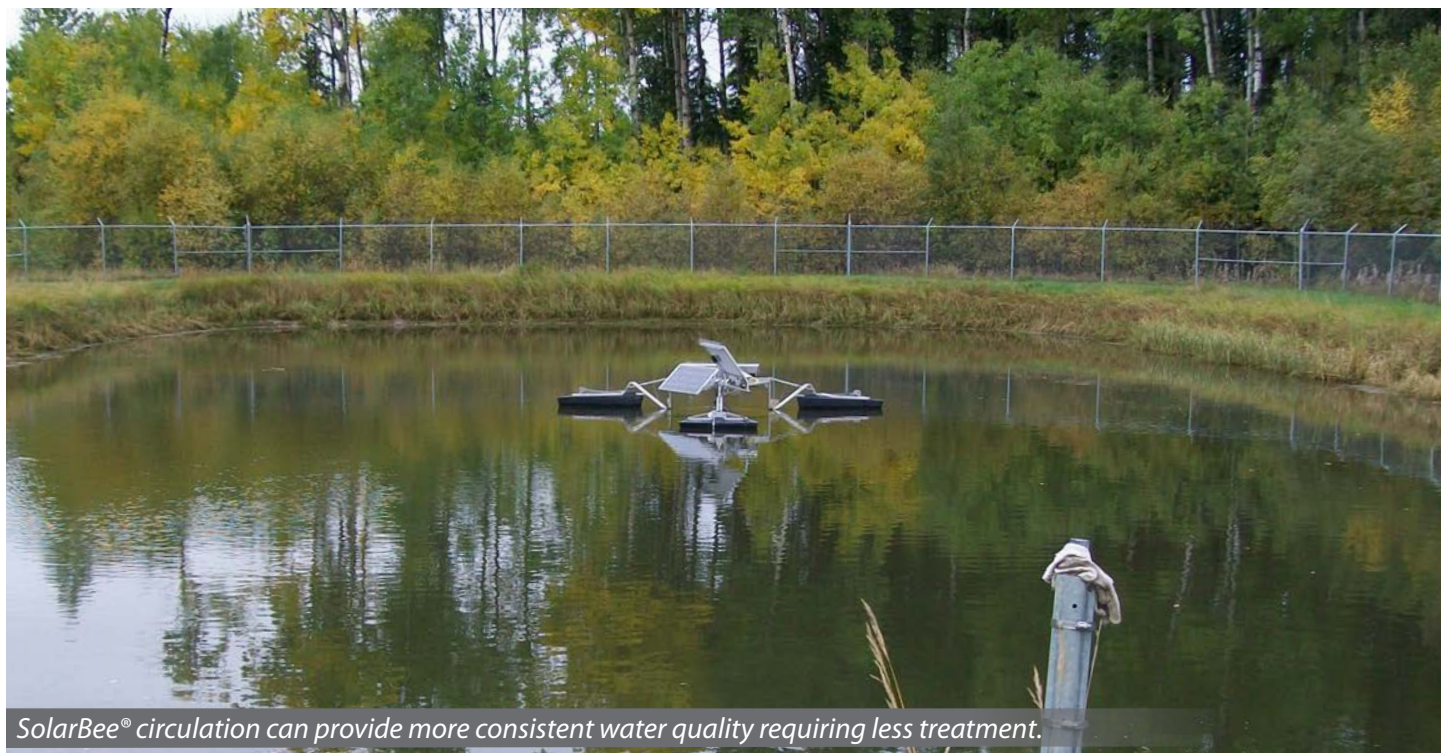
*SolarBee® circulation can provide more consistent water quality requiring less treatment.*

**Solution:** One (1) SolarBee® SB2500v18 Circulator (August 2009)

**Results:** Since the SolarBee deployment, cyanobacteria blooms and aquatic weed growth have been kept under control. The significantly improved water quality resulted in substantially less treatment needs at the plant and an overall cost savings.
